PHASE I ENVIRONMENTAL SITE ASSESSMENT REPORT

GEORGETOWN BUSINESS PARK

For
The City of Georgetown, Kentucky

May 10, 2002

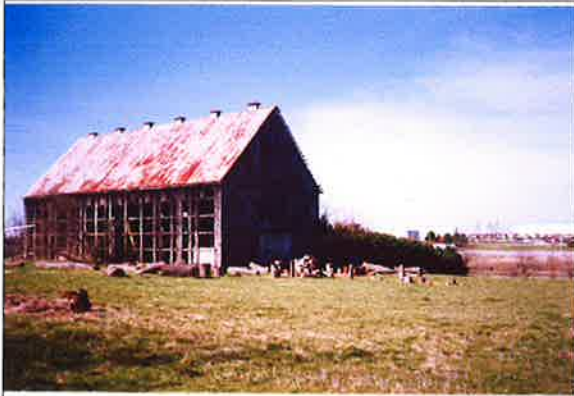
Tobacco Barn - Parcel 4C

This parcel has a somewhat dilapidated tobacco barn with attached tobacco stripping room. The barn and immediate surrounding area is being used by a wood industry.

The parcel should be policed, and all trash, debris, and other material noted above should be removed for proper disposal.

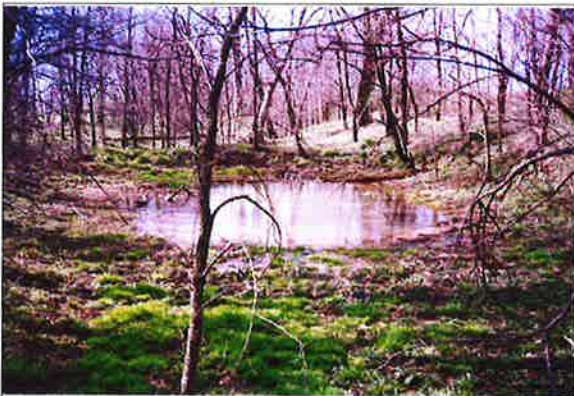
Pond #1 - Parcel 4C

There are two small ponds at the eastern boundary of Parcel 4C. Both ponds appear to be dry during substantial periods of the year.

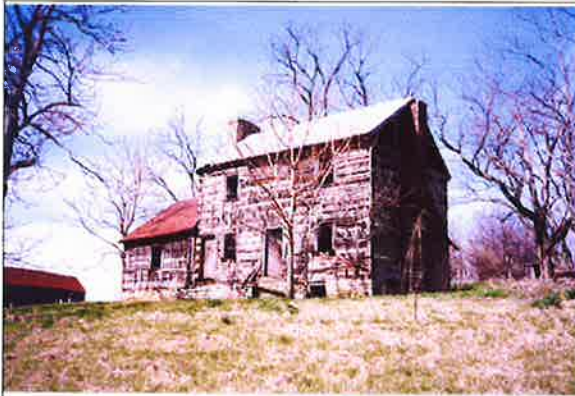
Log House - Parcel 21

A dilapidated log house, barn and outbuilding are located on the north-central portion of Parcel 21. It has obviously been several decades since the house was occupied. It is possible that the log house will be dismantled and moved to another location in Scott County. A vacant mobile home is located on the north side of the parcel. The mobile home has apparently been moved to the site and not connected to utilities nor occupied.

Parcel 21 has most recently been used for hay crops. A well is located near the log house. The well has a concrete encasement and a hatch. A small amount of rubbish is located behind the log house. Two very old pick-up trucks are located in the central portion of the parcel. Two trucks appear to have been parked for several years. There is no readily identifiable contamination from the trucks. Lastly, rusted, horse-drawn farm implements are also located on the parcel.

All of the debris, the farm implements, and the trucks should be removed. After removal of the trucks, the site should be examined in the unlikely event that there has been some contamination from fuel and lubricant leaking.

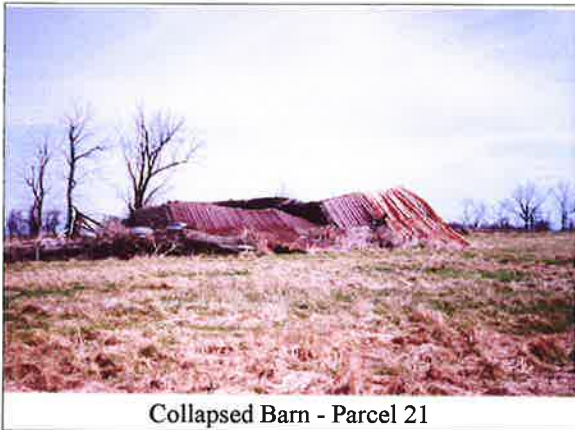
A collapsed barn structure and concrete block remains of another building are on this parcel as are two small farm ponds.

Collapsed Barn - Parcel 21

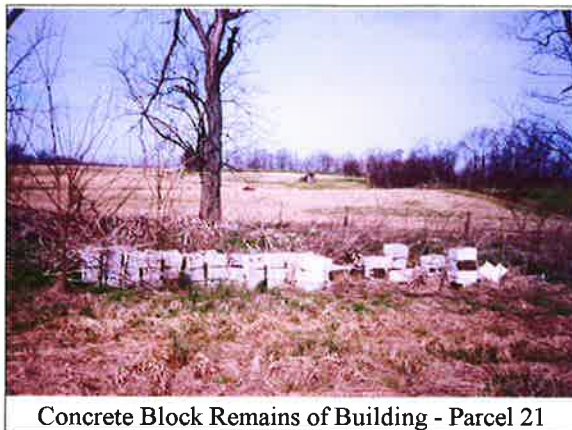
Concrete Block Remains of Building - Parcel 21

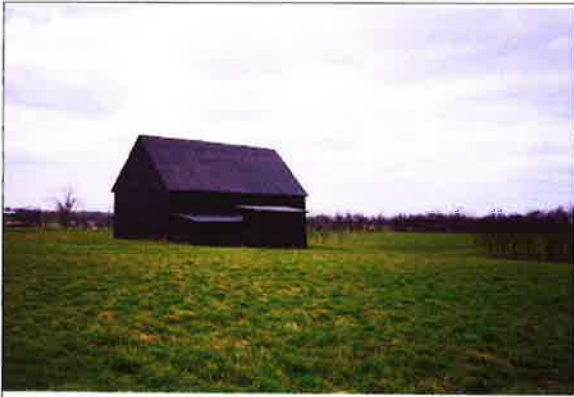
Barn - Parcel 25

The only remaining structures on Parcel 25 are a tobacco barn with an attached tobacco stripping room and a small tool shed. Both structures are in good repair. A house is shown on the 1974 aerial photography, in the Appendix, but has since been removed. A small farm pond is located near the southwestern corner of the parcel.

The remaining barns throughout the Park are being used, or have been used, for cattle and tobacco housing and stripping. The barns on Parcels 35, 33 and 25 are in good repair. No items constituting recognized environmental conditions were observed. The barns on Parcel 21 are either partially or totally collapsed. The only remaining house on the Park property is the log house on Parcel 21. The building is unsafe for entry. No recognized environmental conditions were observed from the doorways or windows.

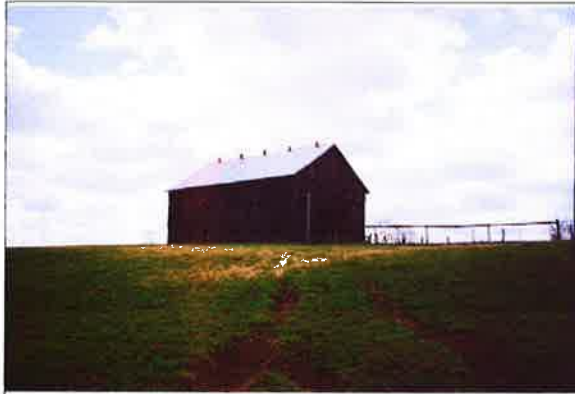
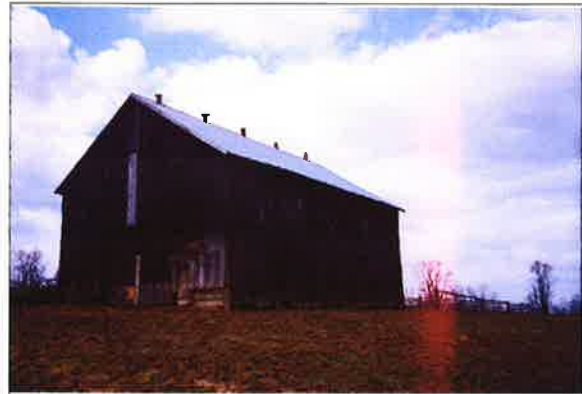
Barn, View 1 - Parcel 33CI

One barn is situated in the pasture field on Parcel 33CI. A house is noted on the 1974 aerial photography but is now gone. No traces of the house remain.

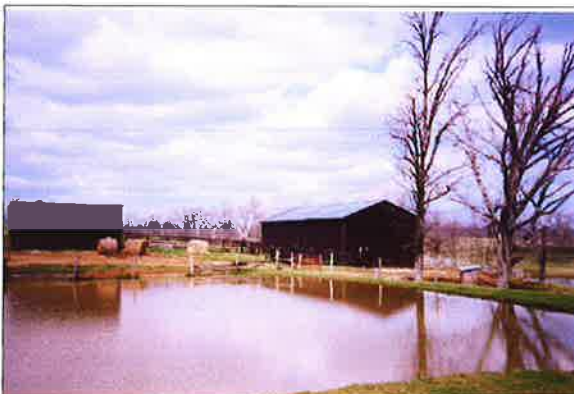
Barn and Tool Shed - Parcel 35

A barn and tool shed are located near the northern boundary of the parcel. Two small farm ponds in series are near the barn and are used for cattle watering.

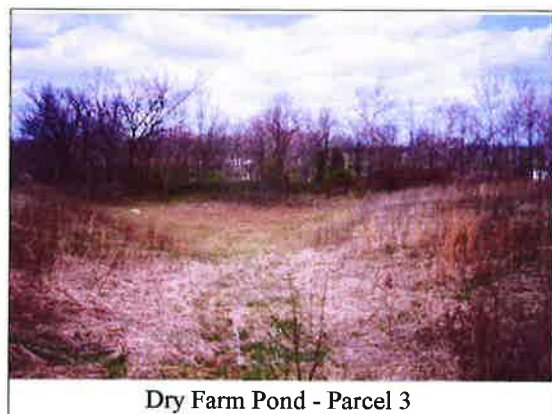
Dry Farm Pond - Parcel 3

The remains of two houses are located on Parcel 3. The foundation, a cellar, an outbuilding, and a well house remain from the first homestead. The foundation and chimney of the second house remain. One farm pond that only impounds in response to recent rainfall is located at the northeastern corner of the parcel.

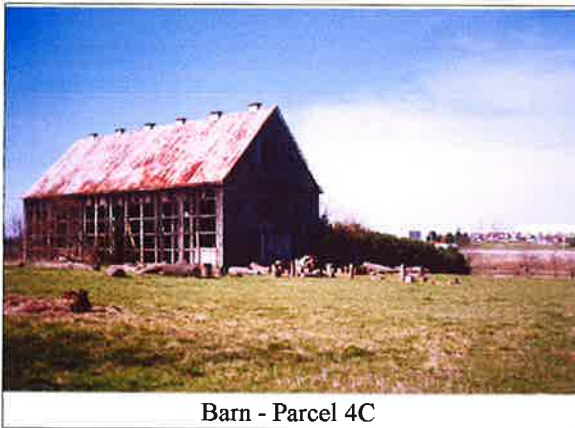
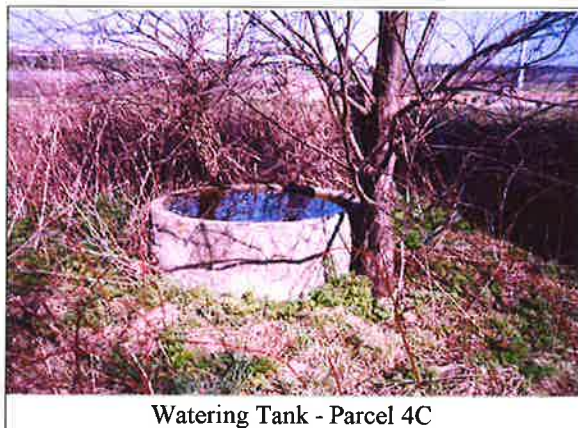
This parcel is located at the southeastern corner of the Park. A barn and surrounding area are being used for a wood industry. There are logs and wood pieces scattered around the barn. A stock watering tank is located on the east side of the barn.

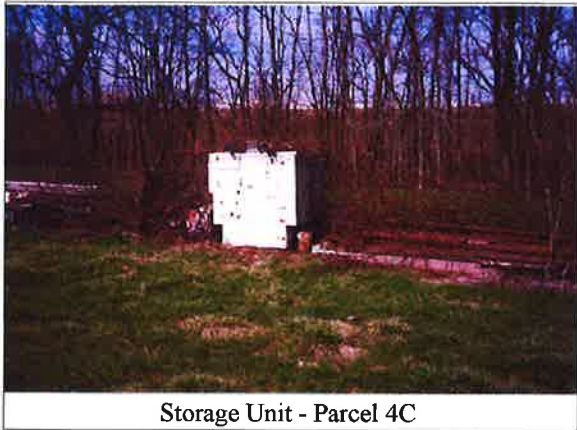
A storage unit, empty aluminum tank, and steel and aluminum building products were observed on the property immediately adjacent to the eastern boundary of Parcel 4C. Although not located on Park property, this material is approximately fifteen feet from the Park property. The storage unit contains general rubbish and one five (5) gallon gasoline can. The aluminum tank appears to be empty. There is no observable evidence of leakage or contamination at this site.

Storage Unit - Parcel 4C

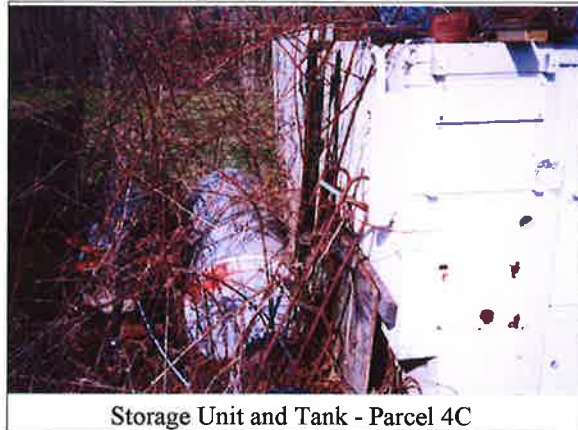
Storage Unit and Tank - Parcel 4C

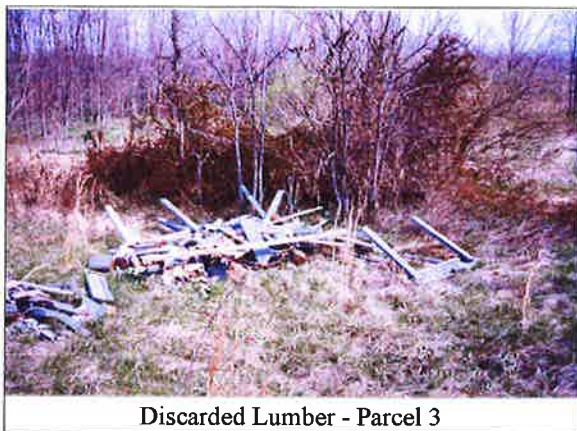
Several locations on Parcel 3 have scattered trash, furniture, abandoned appliances, and automobile motors, roofing shingles, and one empty 55-gallon drum. One discarded automobile battery was located. Many farms have an area where household trash, discarded furniture, and other debris have been dumped. These “farm dumps” characteristically contain material deposited over a significant number of years. A “farm dump” was located at the north-central boundary of Parcel 3.

Discarded Lumber - Parcel 3

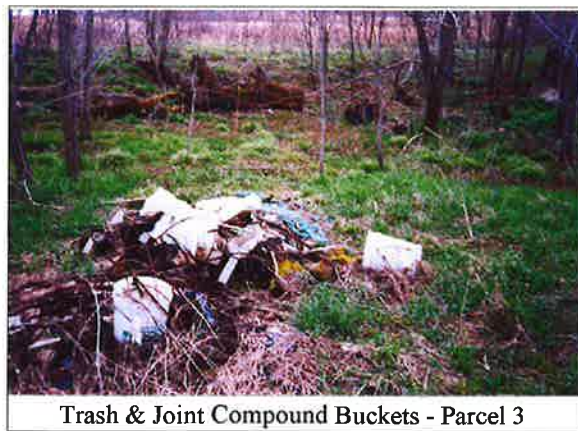
Trash & Joint Compound Buckets - Parcel 3

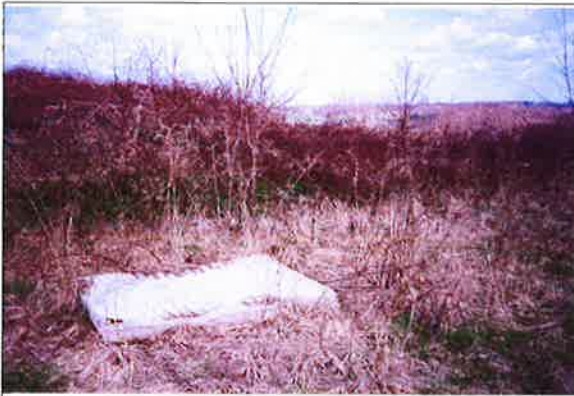
Discarded Mattress - Parcel 3

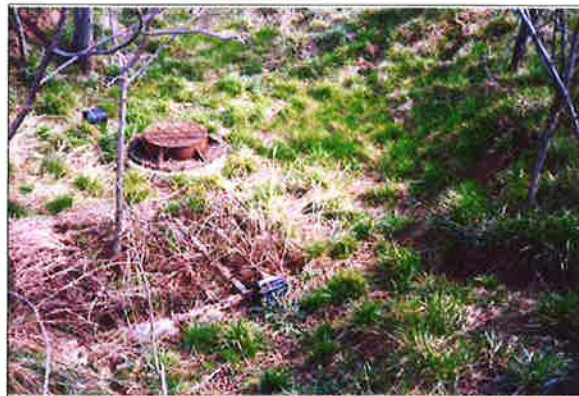
Discarded Battery - Parcel 3

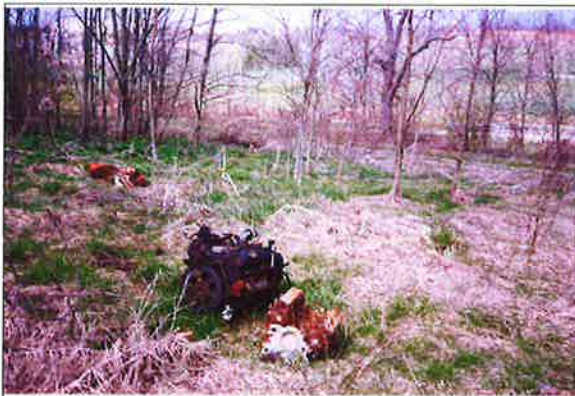
Automobile Motors - Parcel 3

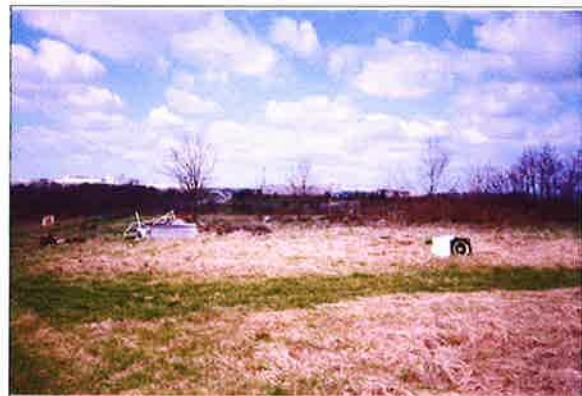
Discarded Appliances - Parcel 3

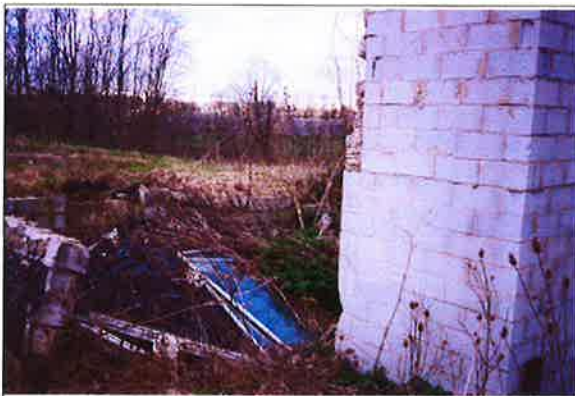
Roofing Shingles - Parcel 3

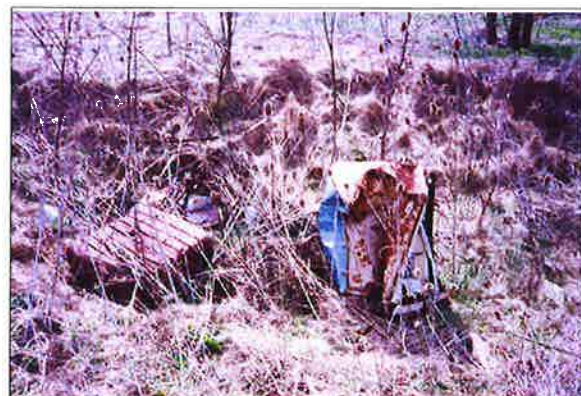
Auto Gas Tank & Discarded Refrigerator - Parcel 3

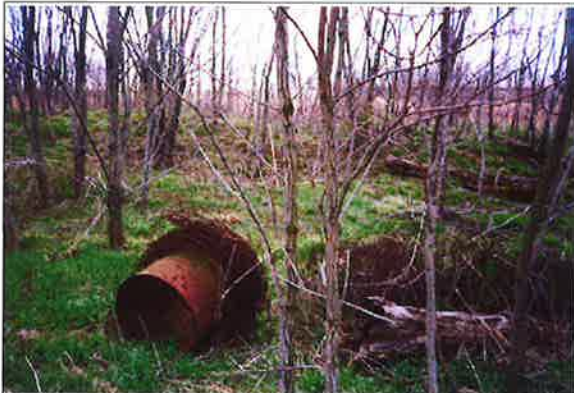
Empty Drum - Parcel 3

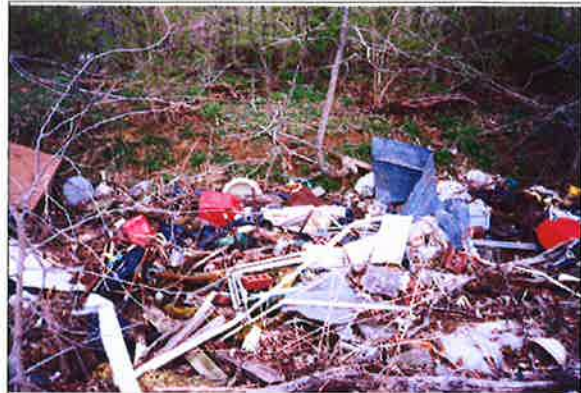
Farm Dump - Parcel 3

Several locations on Parcel 3 have scattered trash, furniture, abandoned appliances, and automobile motors, roofing shingles, and one empty 55-gallon drum. One discarded automobile battery was located. Many farms have an area where household trash, discarded furniture, and other debris have been dumped. These “farm dumps” characteristically contain material deposited over a significant number of years. A “farm dump” was located at the north-central boundary of Parcel 3.

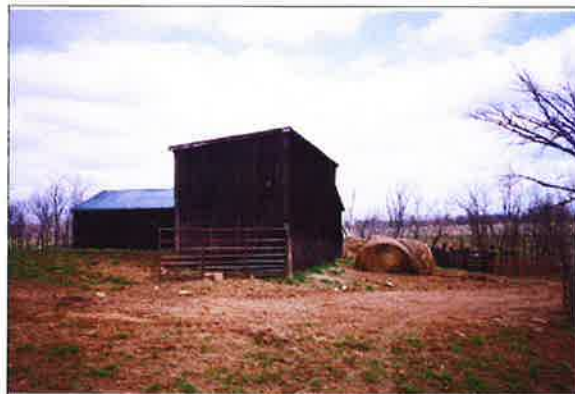
Parcel 35 is used for cattle grazing. Hay rolls are stored outside the cattle shed near the cattle barn. The parcel is free of trash.

Cattle Shed and Barn - Parcel 35

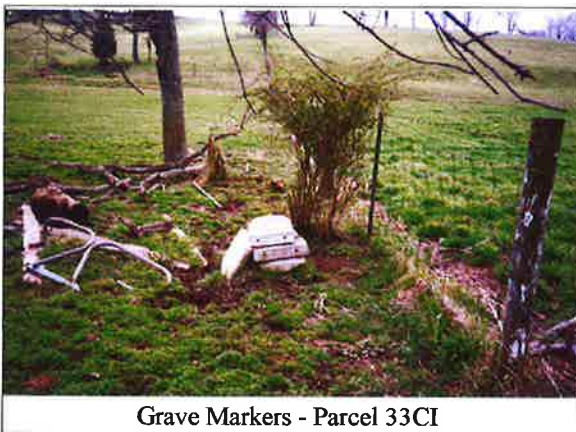
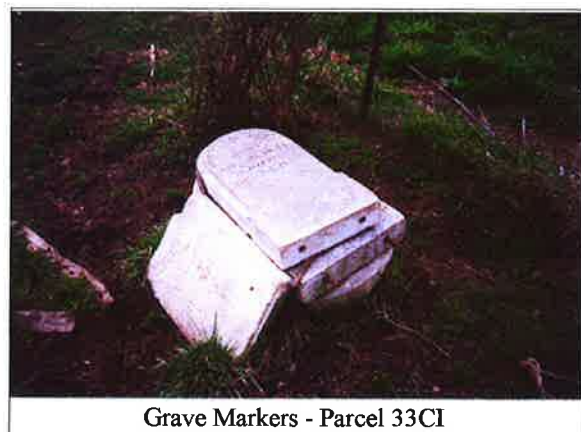
A stack of white marble grave markers is located at the fence line on the western side of the house site. One of the grave markers is inscribed “William Risk, August 21, 1841 - July 24, 1882.” Another marker notes that the person died on March 1, 1863 and was 35 years old.

Records at the Kentucky History Center in Frankfort were reviewed in an attempt to determine the original location of the grave markers. An 1879, Beers, Lanahan County Map of Scott County shows no cemetery on Park property. That map shows the house mentioned above is the J.A. Risk property. Additionally, a 1939 15-Minute Topographic Quadrangle Map was reviewed. That map shows no cemeteries on Park property.

The previous owners of the property, Doug Smith and Marion Cox were interviewed. These gentlemen had purchased the property in 1998. Neither Messrs. Doug Smith nor Marion Cox had knowledge of the source of the grave markers. Next, the previous owner, Fred K. Smith, was interviewed. The property had been in Mr. Fred K. Smith's family for several decades. He was not able to give any location information for the grave markers.

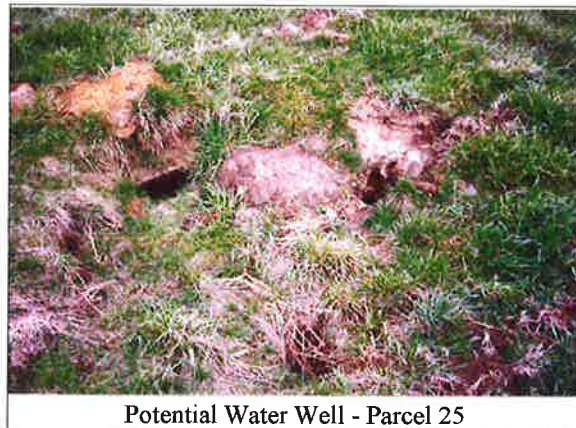
The 1978 aerial photography shows two house locations on this parcel. One house was located just east of the barn structure described earlier. The 1998 photography shows that this house has been removed. The owner, Mr. Guy Barkley, stated that there was a water well at the house. The following photograph likely is of the well site. Its location is near the site of the house.

Potential Water Well - Parcel 25

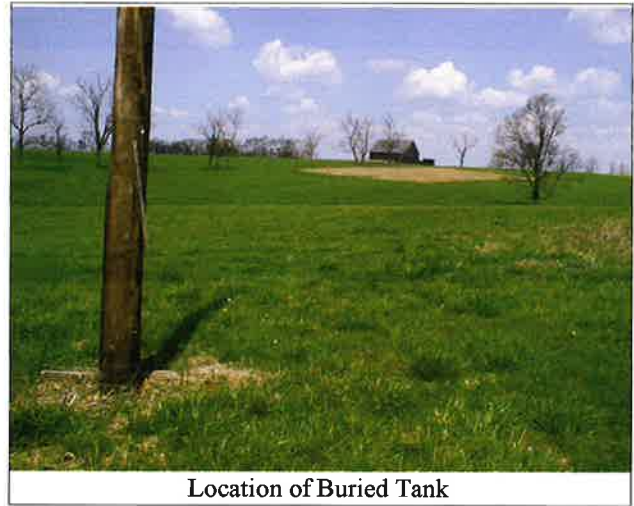
Another house was located at the southeastern corner of the property on Parcel 22. This house was Mr. Barkley's residence and was taken by the improvements to U.S. 62. Mr. Barkley mentioned the existence of a 300-gallon storage tank buried near this second house. The following map is from the right-of-way plans for the reconstruction of U.S. 62. The location of the buried tank is shown.

A household septic tank, which was located immediately behind the Barkley house, is also shown on the following drawing. This tank should be filled.

Location of Buried Tank

The only recognized environmental condition identified during the investigation was a 300-gallon buried underground storage tank on Parcel 22.

The condition of the 300-gallon buried underground storage tank on Parcel 22 is not known. If the tank has leaked there may be resulting contamination. An excavation and removal of the tank, with necessary sampling and laboratory work, will be necessary in order to determine if any contamination is present. It is unlikely that any contamination will be beyond the capability for clean-up. The tank should be registered with the Department for Environmental Protection,

This tank should be registered with the Department for Environmental Protection, Division of Waste Management. Documents should be filed requesting removal and closure of the tank site. Funds for remediation of any contamination are probably available from the Kentucky Petroleum Storage Tank Environmental Assurance Fund.

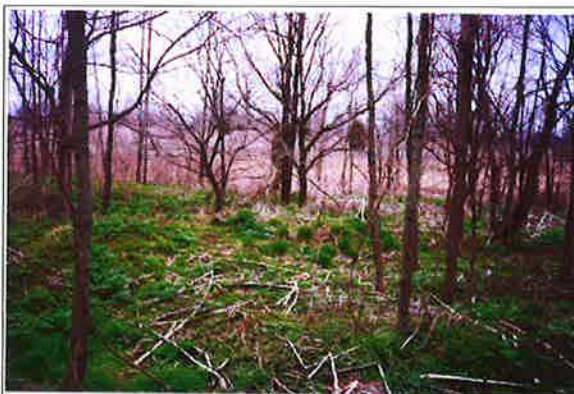
The 1974 aerial photographs included in the Appendix shows a large building, probably a barn and other smaller buildings, near the southwestern corner of the parcel. These buildings are no longer present. A pile of logs, metal, and used tires is located near the old barn location and probably contains residue from the structures.

Former Building Site - Parcel 61

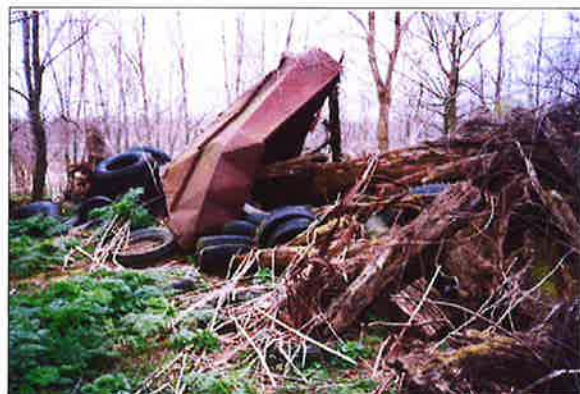
Discarded Tires - Parcel 61

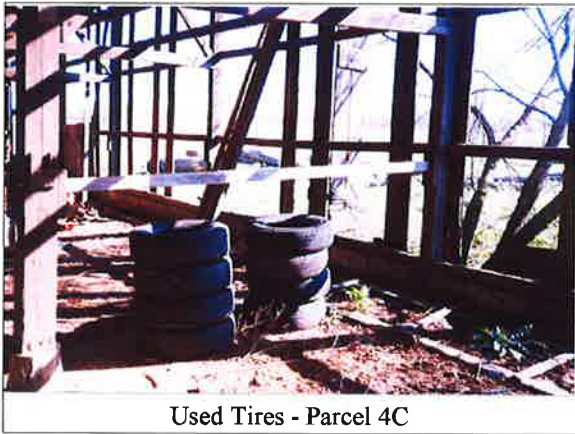
The barn on Parcel 4C has several items that should be removed for property disposal, including:

Used Tires - Parcel 4C

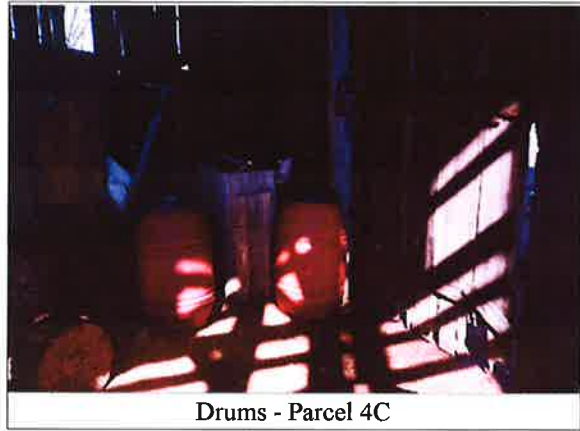
Drums - Parcel 4C

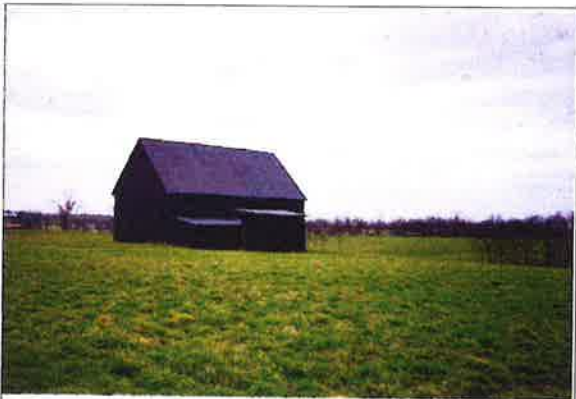
The only remaining structures on Parcel 25 are a tobacco barn with an attached tobacco stripping room and a small tool shed. Both structures are in good repair. A house is shown on the 1974 aerial photography, in the Appendix, but has since been removed. A small farm pond is located near the southwestern corner of the parcel.

Barn - Parcel 25

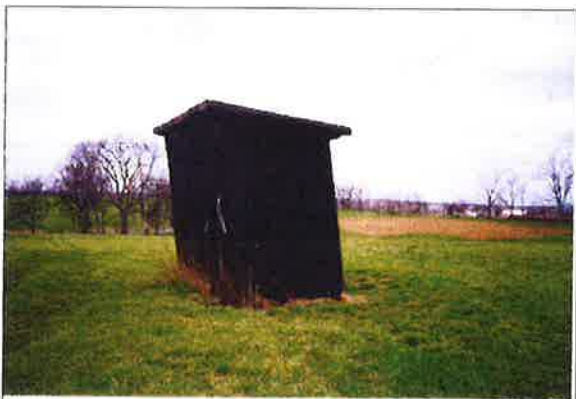
Tool Shed - Parcel 25

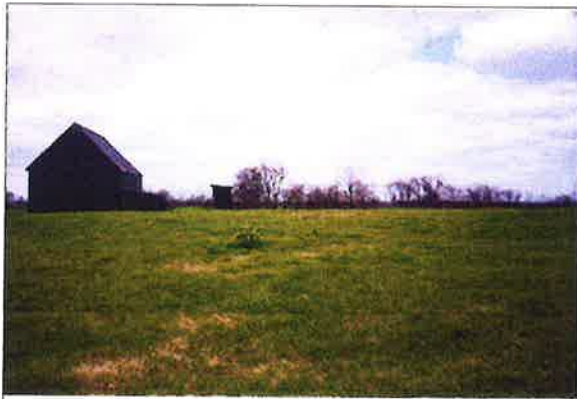
Previous House Site in Foreground - Parcel 25

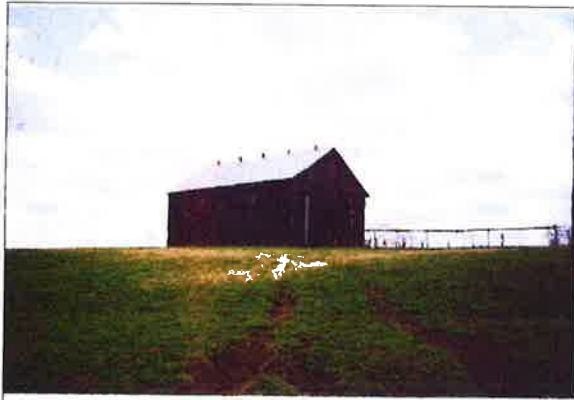
One barn is situated in the pasture field on Parcel 33CI. A house is noted on the 1974 aerial photography but is now gone. No traces of the house remain.

Barn, View 1 - Parcel 33CI

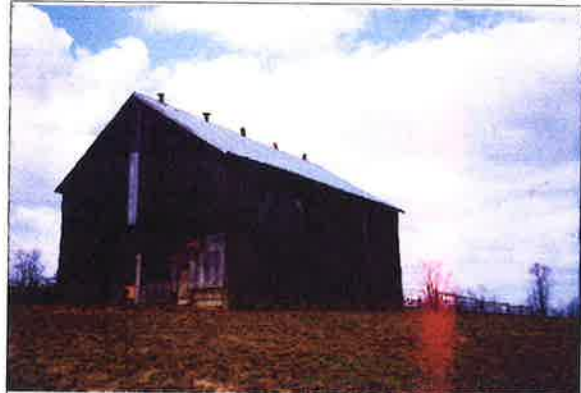
Barn, View 2 - Parcel 33CI

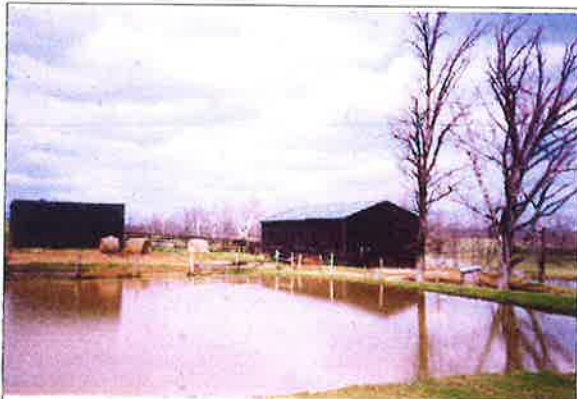
A barn and tool shed are located near the northern boundary of the parcel. Two small farm ponds in series are near the barn and are used for cattle watering.

Barn and Tool Shed - Parcel 35

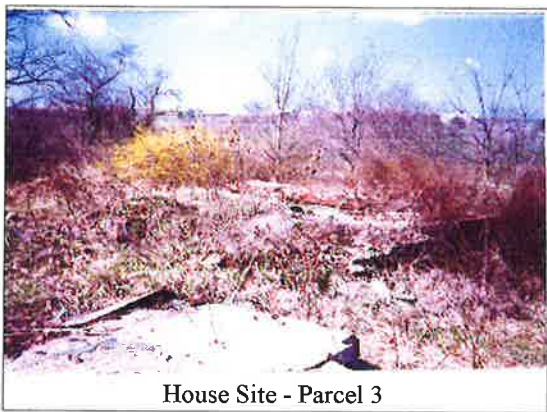
The remains of two houses are located on Parcel 3. The foundation, a cellar, an outbuilding, and a well house remain from the first homestead. The foundation and chimney of the second house remain. One farm pond that only impounds in response to recent rainfall is located at the northeastern corner of the parcel.

House Site - Parcel 3

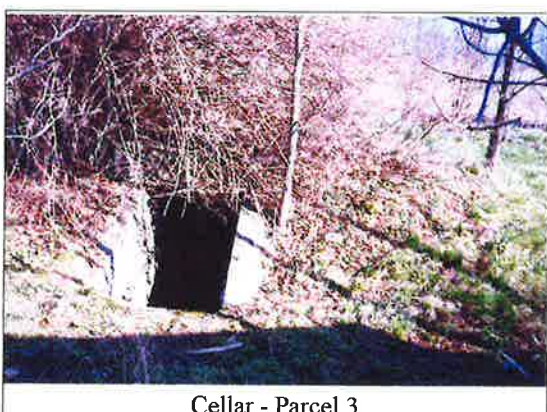
Cellar - Parcel 3

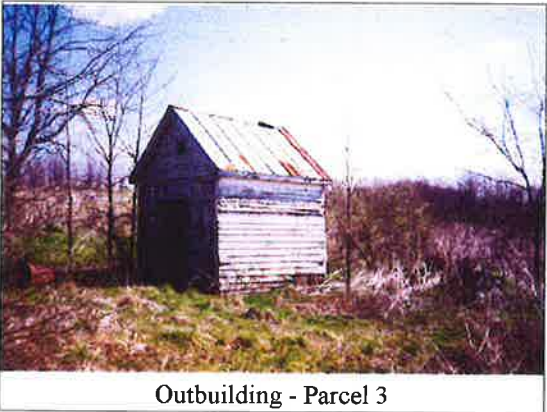
Outbuilding - Parcel 3

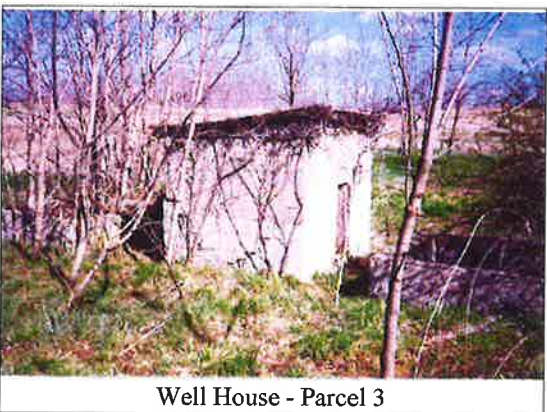
Well House - Parcel 3

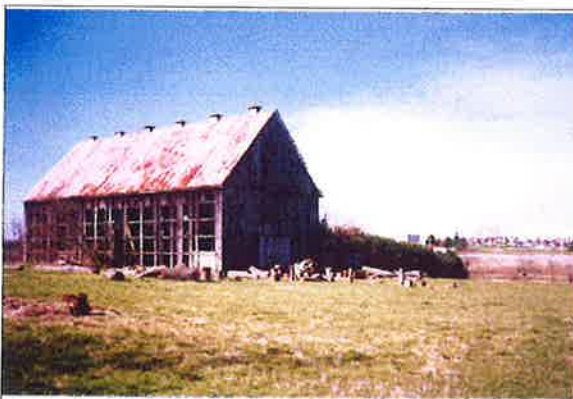
This parcel is located at the southeastern corner of the Park. A barn and surrounding area are being used for a wood industry. There are logs and wood pieces scattered around the barn. A stock watering tank is located on the east side of the barn.

Barn - Parcel 4C

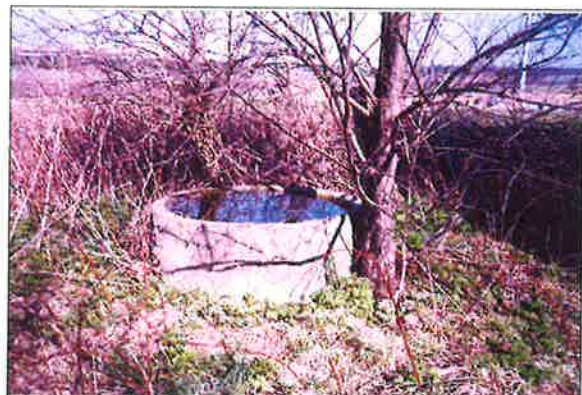
Watering Tank - Parcel 4C

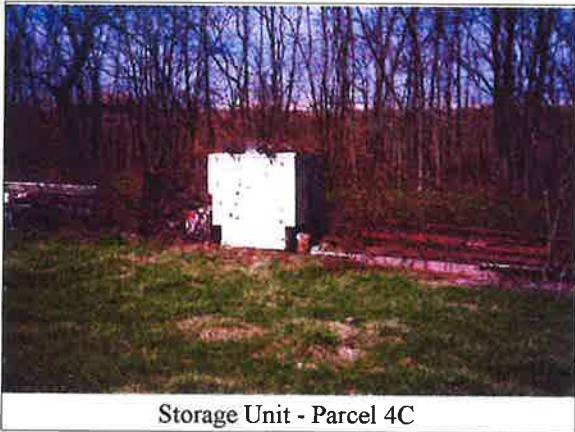
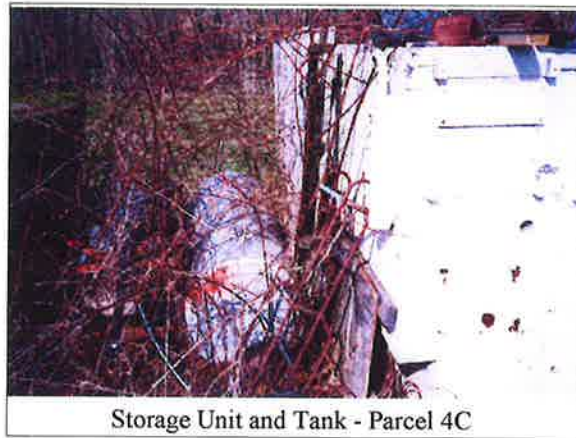
A storage unit, empty aluminum tank, and steel and aluminum building products were observed on the property immediately adjacent to the eastern boundary of Parcel 4C. Although not located on Park property, this material is approximately fifteen feet from the Park property. The storage unit contains general rubbish and one five (5) gallon gasoline can. The aluminum tank appears to be empty. There is no observable evidence of leakage or contamination at this site.

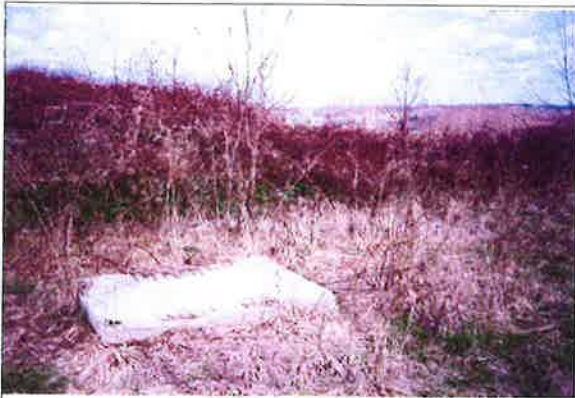
Discarded Mattress - Parcel 3

The parcel should be policed, and all trash, debris, and other material noted above should be removed for proper disposal.

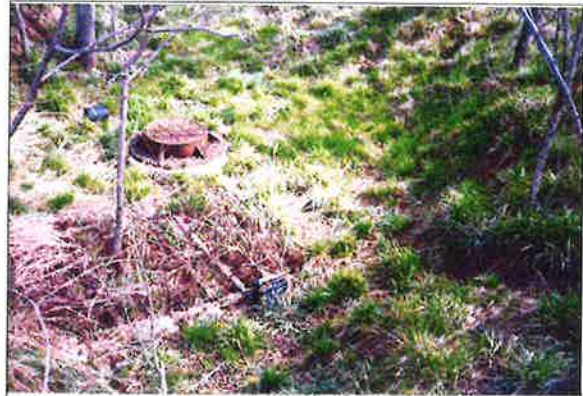
Discarded Battery - Parcel 3

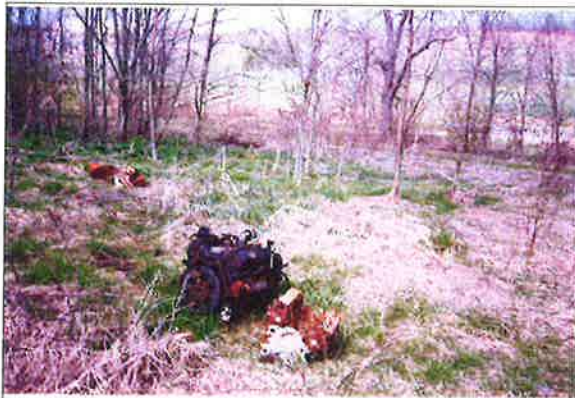
Automobile Motors - Parcel 3

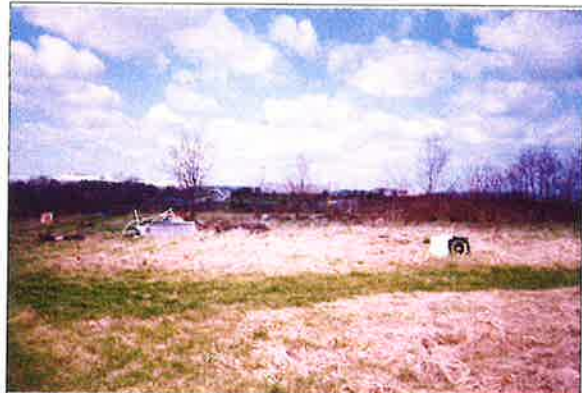
Discarded Appliances - Parcel 3

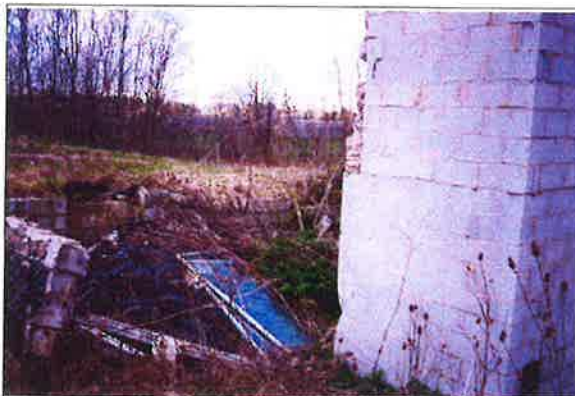
Roofing Shingles - Parcel 3

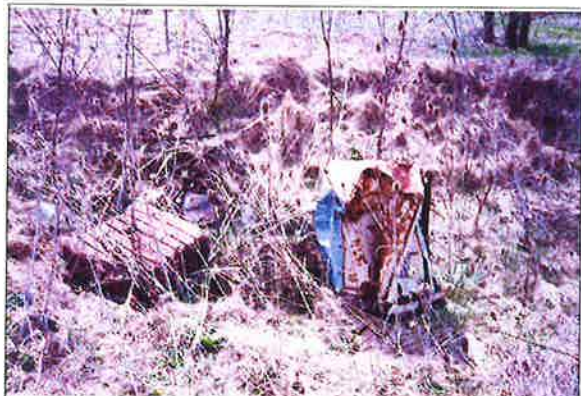
Auto Gas Tank & Discarded Refrigerator - Parcel 3

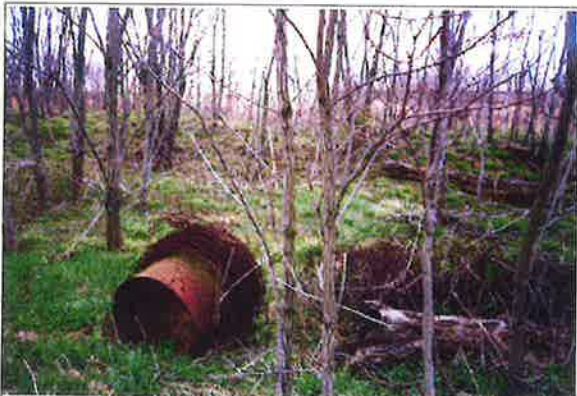
Empty Drum - Parcel 3

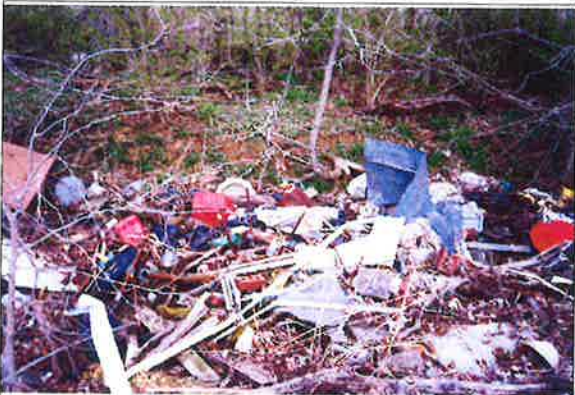
Farm Dump - Parcel 3

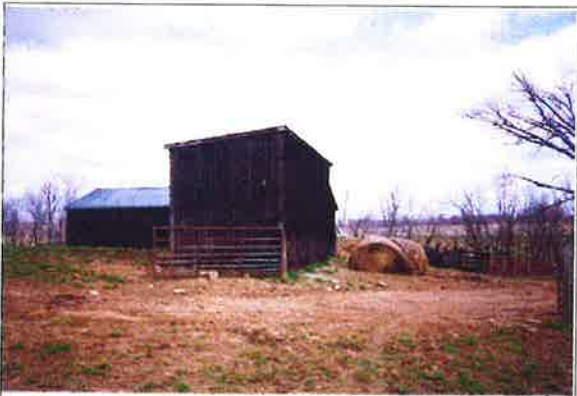
Parcel 35 is used for cattle grazing. Hay rolls are stored outside the cattle shed near the cattle barn. The parcel is free of trash.

Cattle Shed and Barn - Parcel 35

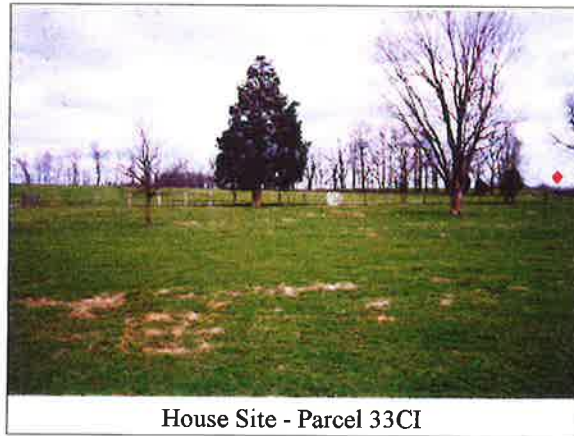
Parcel 33CI is used for cattle grazing, and the only remaining structure is one barn discussed earlier in this report. The 1974 and 1998 aerial photographs in the Appendix show a house and associated outbuildings located at the northwest corner of the parcel. This house and improvements have been removed. The site is not readily discernable in the field.

House Site - Parcel 33CI

A stack of white marble grave markers is located at the fence line on the western side of the house site. One of the grave markers is inscribed “William Risk, August 21, 1841 - July 24, 1882.” Another marker notes that the person died on March 1, 1863 and was 35 years old.

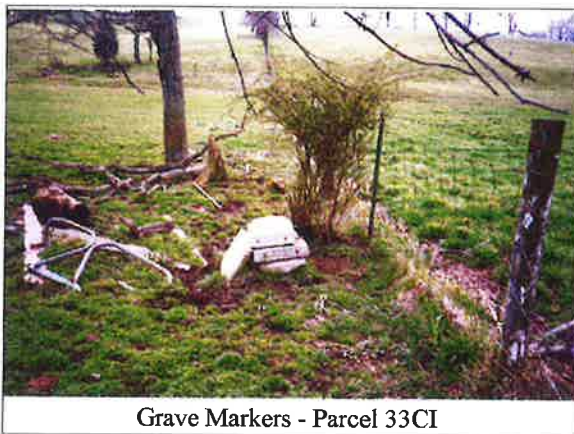
Grave Markers - Parcel 33CI

Records at the Kentucky History Center in Frankfort were reviewed in an attempt to determine the original location of the grave markers. An 1879, Beers, Lanahan County Map of Scott County shows no cemetery on Park property. That map shows the house mentioned above is the J.A. Risk property. Additionally, a 1939 15-Minute Topographic Quadrangle Map was reviewed. That map shows no cemeteries on Park property.

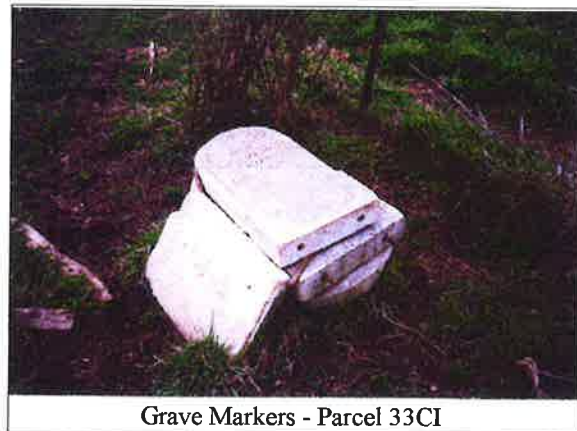
Grave Markers - Parcel 33CI

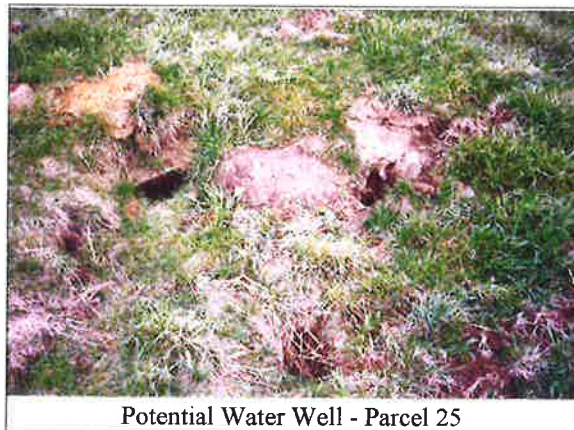
The 1978 aerial photography shows two house locations on this parcel. One house was located just east of the barn structure described earlier. The 1998 photography shows that this house has been removed. The owner, Mr. Guy Barkley, stated that there was a water well at the house. The following photograph likely is of the well site. Its location is near the site of the house.

Potential Water Well - Parcel 25

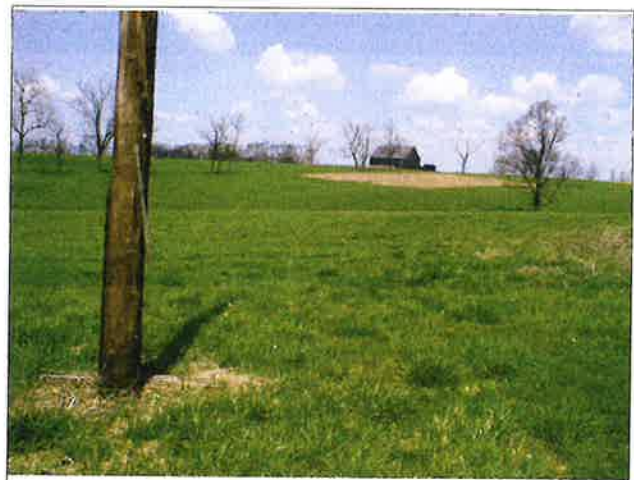
Another house was located at the southeastern corner of the property on Parcel 22. This house was Mr. Barkley's residence and was taken by the improvements to U.S. 62. Mr. Barkley mentioned the existence of a 300-gallon storage tank buried near this second house. The following map is from the right-of-way plans for the reconstruction of U.S. 62. The location of the buried tank is shown.

A household septic tank, which was located immediately behind the Barkley house, is also shown on the following drawing. This tank should be filled.

Location of Buried Tank

The only recognized environmental condition identified during the investigation was a 300-gallon buried underground storage tank on Parcel 22.

The condition of the 300-gallon buried underground storage tank on Parcel 22 is not known. If the tank has leaked there may be resulting contamination. An excavation and removal of the tank, with necessary sampling and laboratory work, will be necessary in order to determine if any contamination is present. It is unlikely that any contamination will be beyond the capability for clean-up. The tank should be registered with the Department for Environmental Protection,

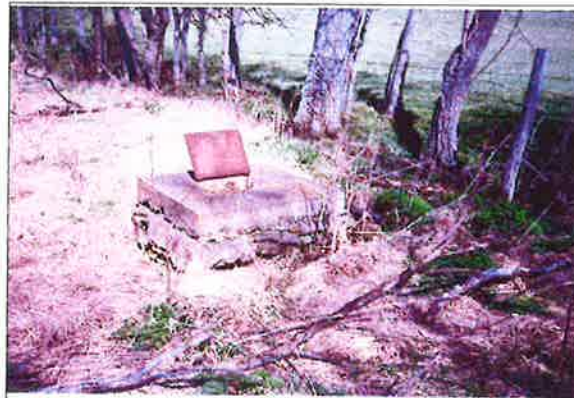
Parcel 21 has most recently been used for hay crops. A well is located near the log house. The well has a concrete encasement and a hatch. A small amount of rubbish is located behind the log house. Two very old pick-up trucks are located in the central portion of the parcel. Two trucks appear to have been parked for several years. There is no readily identifiable contamination from the trucks. Lastly, rusted, horse-drawn farm implements are also located on the parcel.

Well - Parcel 21

All of the debris, the farm implements, and the trucks should be removed. After removal of the trucks, the site should be examined in the unlikely event that there has been some contamination from fuel and lubricant leaking.

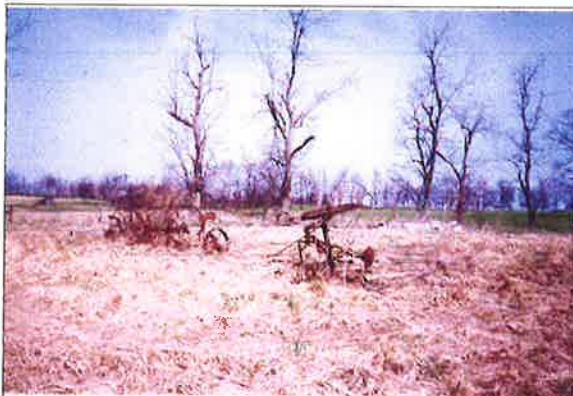
Farm Implements - Parcel 21

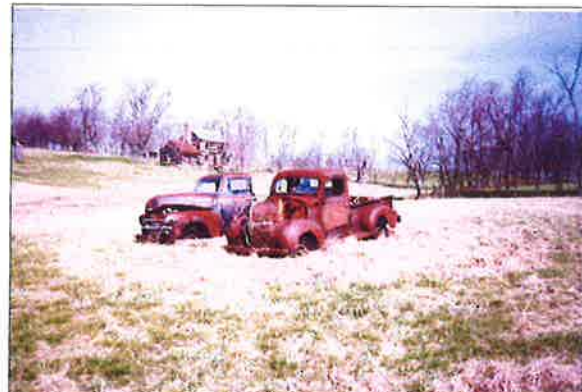
Trucks - Parcel 21

Other identified environmental conditions described are not recognized environmental conditions. Nevertheless, all the items described should be collected and removed for proper disposal. The site of the two rusted trucks on Parcel 21 should be examined to determine if any leakage of fuel or lubricants has occurred. Any significant contamination is unlikely.

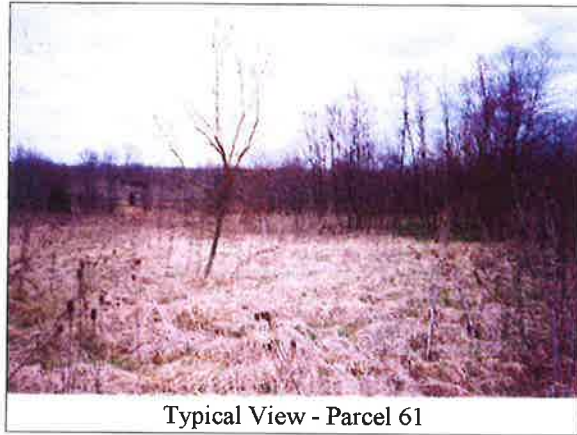
Parcel 61 is located at the northwest corner of the Park property. It has obviously been several years since the land was used for crops or grazing. The land is overgrown with thick fescue and small trees.

Typical View - Parcel 61

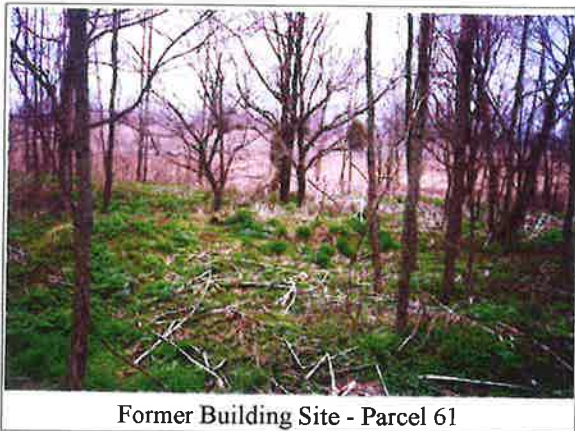
The 1974 aerial photographs included in the Appendix shows a large building, probably a barn and other smaller buildings, near the southwestern corner of the parcel. These buildings are no longer present. A pile of logs, metal, and used tires is located near the old barn location and probably contains residue from the structures.

Former Building Site - Parcel 61

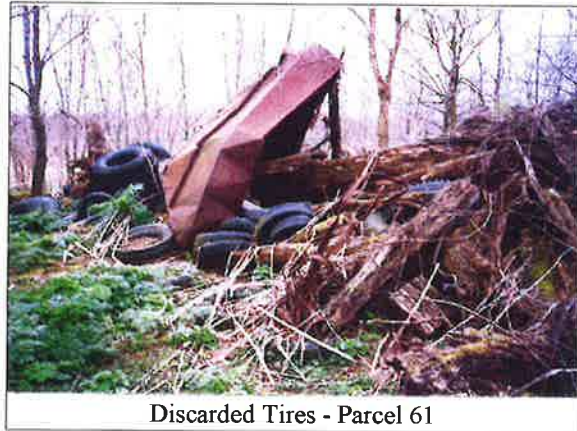
Discarded Tires - Parcel 61

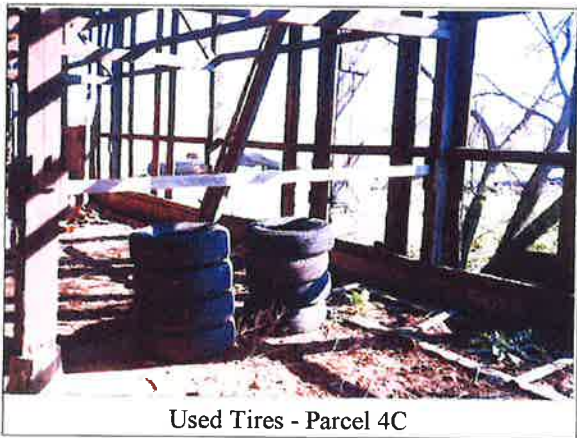
- 1 - gallon jug of bar and chain oil
- 1 - 2½ gallon gasoline can
- 1 - empty anti-freeze containers
 - several used tires
 - used appliances
 - trash
- 2 - unlabeled plastic drums

Used Tires - Parcel 4C

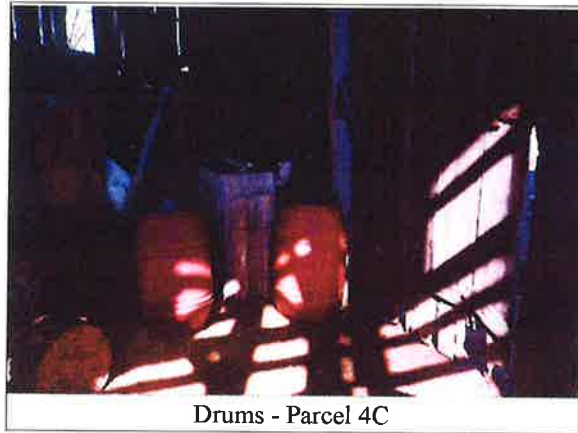
Drums - Parcel 4C
